INTEL PROSET/WIRELESS WIFI SOFTWARE V18.40.3 HF PV RELEASE

WiFi Software TIC # AHWFW2027G
ww20, 2016

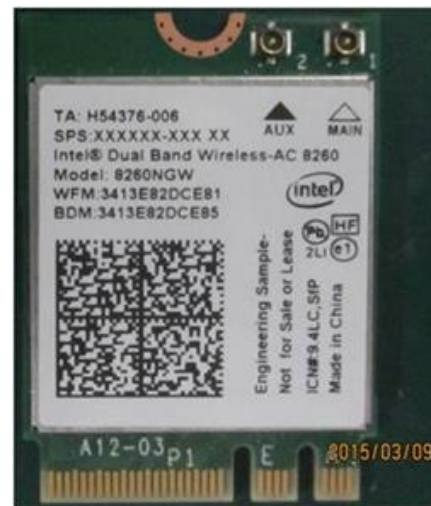
8260 Sample	Stepping	TA #
Pre-ES	A0	H51166-003
ES	K0	H40395-005 H60839-001 H60836-001
ES2	B0	H54376-003
ES3	B2	H54376-006
QS	C0	H69709-001 H69711-001 H69712-001 H69714-001 H74659-001 H74660-001 H69710-001 (1216) H69713-001 (1216)
Supplemental QS	C0	H86028-001 (2230) Red Dot on Label (1216)

Example:
Snowfield Peak / 8260
ES3 / B2 2230 MS
TA # H54376-006

By design, this Beta2 Update WiFi SW will present a Yellow Bang in Device Manager if executed over Snowfield Peak preES/A0, ES/K0, and ES2/B0 hardware. This was purposely done to avoid wasted validation effort and issues worked/submitted because of using incorrect HW. **So if a YB encountered, check for correct HW first.**

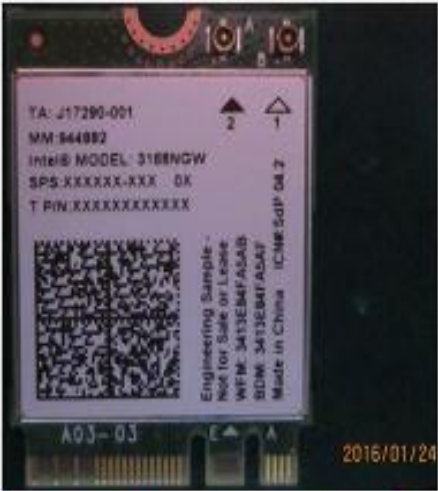
Product Label P/N: G87073-002

3168 Sample	TA #
QS	J17290-001
	J17352-001
	J17784-001
	J17786-001
	J17790-001
	J17800-001
	J17836-001
	J17839-001

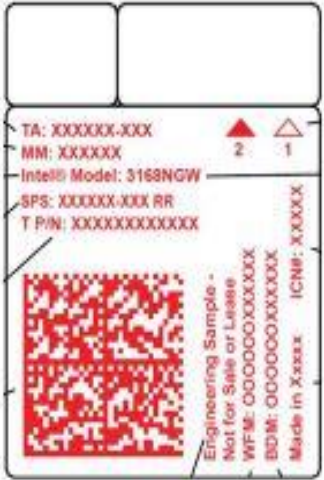
Barcode Content

OEM Labelbarcode ScanContent

3413E84FA5AB056WZJ17290001
GXXXX0X779Z0QCXXXXXXXXXXXXXXXXXXXXXXX

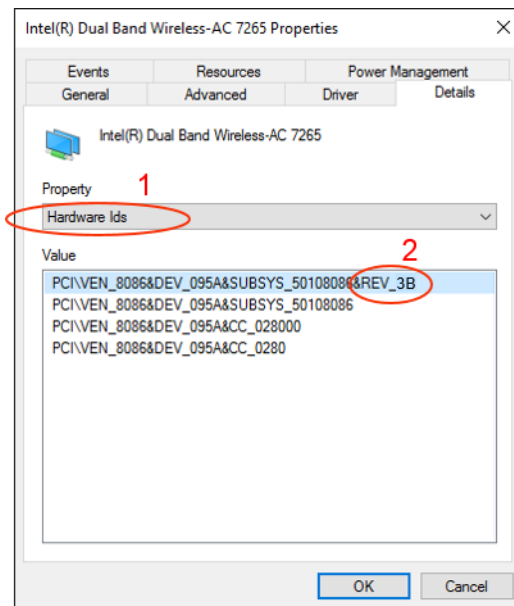
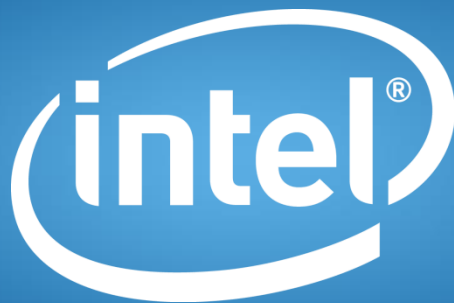
How to identify a Stone Peak 2 C0-SKU in the system (vs. a StP2-D0 or D1 sku)?

- The StP2-C0 SKU (Intel® Dual Band Wireless-AC 7265 – C0 sku) can be identified using the Details tab in Device Manager.
- In the Details tab, select the 'Hardware Ids' (1) string in the Property field.
- The REVID parameter (2) will indicate if a StP2-C0 card is present in the system.
- The following REVIDs indicate a StP2-C0 SKU:
 - REV_3B
 - REV_43
 - REV_48
 - REV_50
- If REVIDs are not in list above then the adapter is a D step
